DAILY PROJECT OVERSIGHT LOG

PROJECT NAME:	Demo/abatement	DATE:	3/2/15
SITE ADDRESS:	DVC, 321 Golf Club Rd, Pleasant Hill	RGA PROJECT NUMBER:	R1147447
CLIENT CONTACT:		HOURS OF WORK:	0700 – 1500
CLIENT PHONE #:			
CONTRACTOR:	CPM Environmental	NUMBER OF WORKERS:	7
RGA REPRESENTATIVE:	N. Arscott	NUMBER OF ACM AIR SAMPLES:	TEM:
			PCM: 4
RGA P.M.:	S. Steiner	NUMBER OF LEAD SAMPLES:	AIR:
			WIPE/BULK:

**PROJECT: R1147447 -
TIME AND ACTIVITY**

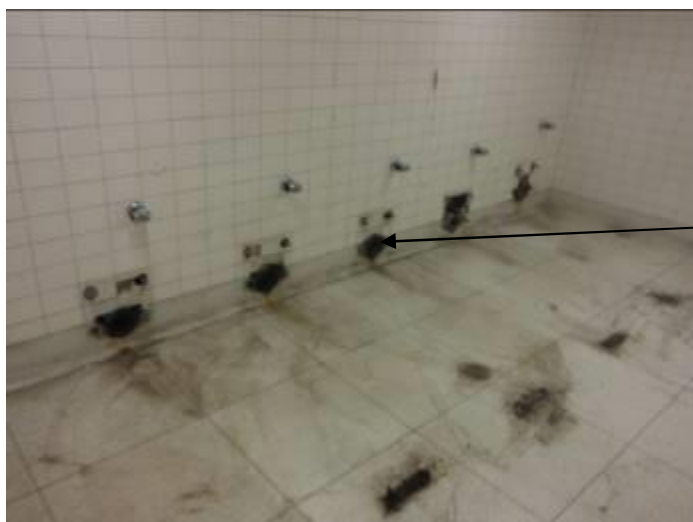
Sewage smells permeate the containment, and extend out to the public area, in the entrance lobby, south of the containment. This is caused by the NAMs drawing the foul air out of open toilet lines left after removal of the bowls. RGA requests the open ends be plugged.

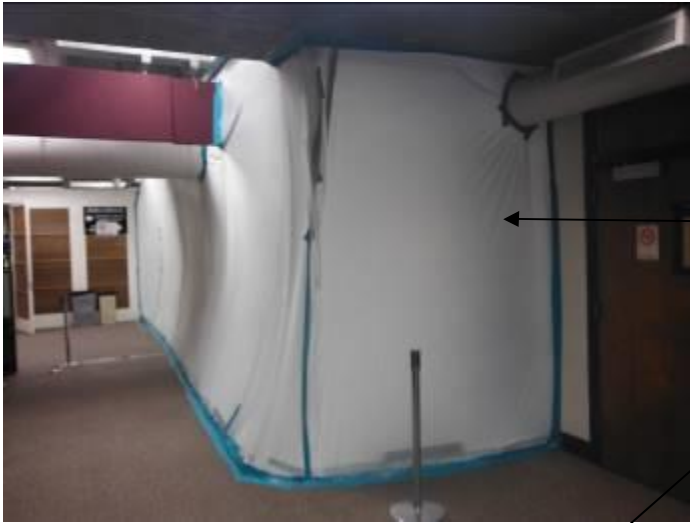
RGA notes very strong negative pressure, and points out that it could strain the tall, floor-to-ceiling poly barriers that separate the containment from the public, and populated, part of the library to the southeast...

...and the Media Services office to the southwest.

The CPM foreman is aware, and states he will monitor the pressure, and reduce it if the tape seams show any signs of yielding. For now, the decon flaps are used to control the pressure down to below -0.050"

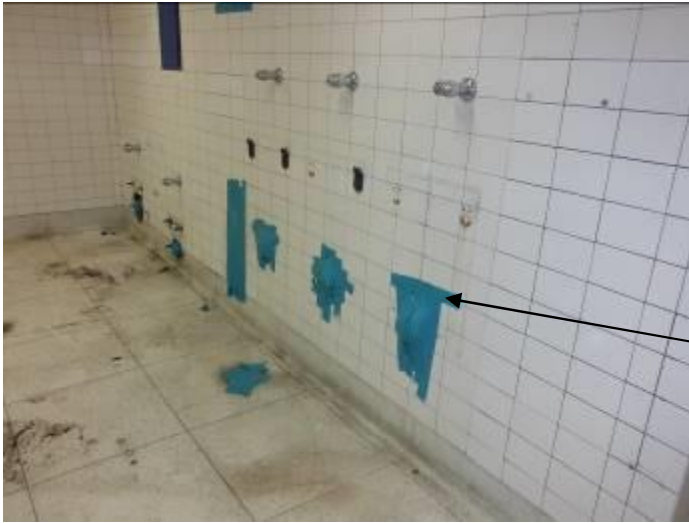
1010 The toilet sewer connections are almost flush with the wall, making it difficult to seal around the pipe I.D.

The crew has stuffed rags into the pipes and held them in place with tape. RGA points out the rags are permeable, and only the tape is holding in any fumes.

The crew attempts to seal against the wall, but RGA expresses concern that this simply re-directs the fumes up the wall cavity.

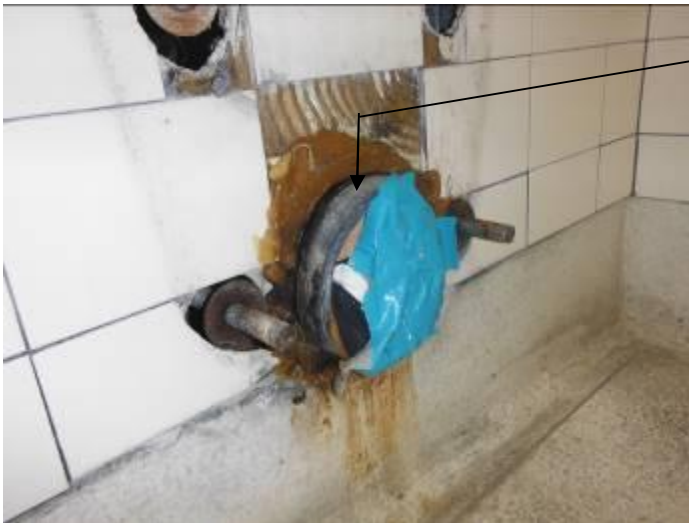
On some of the pipes, the tape is attached to the soft rubber, or wax, seal ring, allowing fumes to escape around the edge. RGA suggests expanding plugs, but CPME explains that is the plumbers' responsibility.

W.E. Lyons suggests that, since the walls are scheduled for demolition, to go ahead and break out a hole big enough to reach in and around the pipes, and seal taper against the O.D.

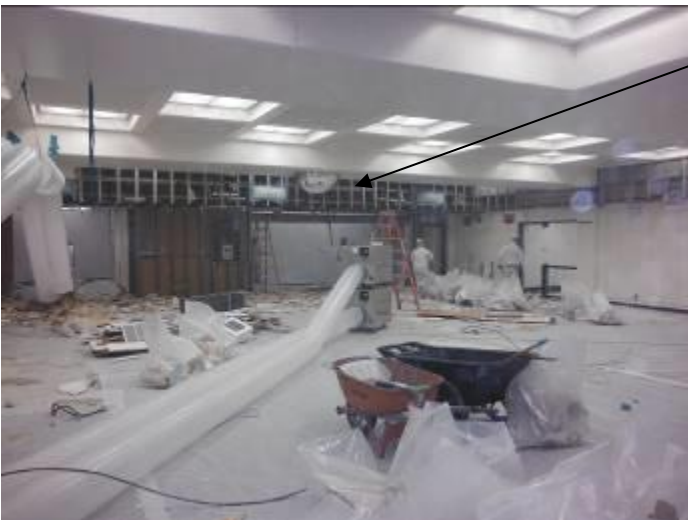
The soffits are mostly stripped of drywall, but RGA notes dust, and exhorts the crew to use the airless sprayer more liberally.

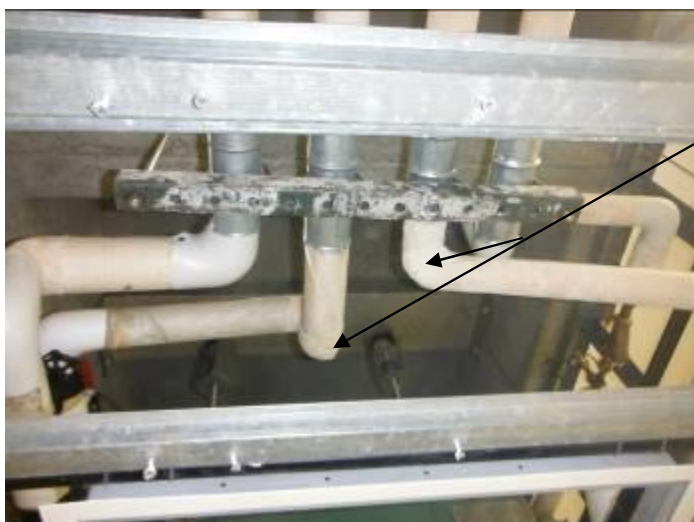
...but a few hard-packed elbows and couplers remain...

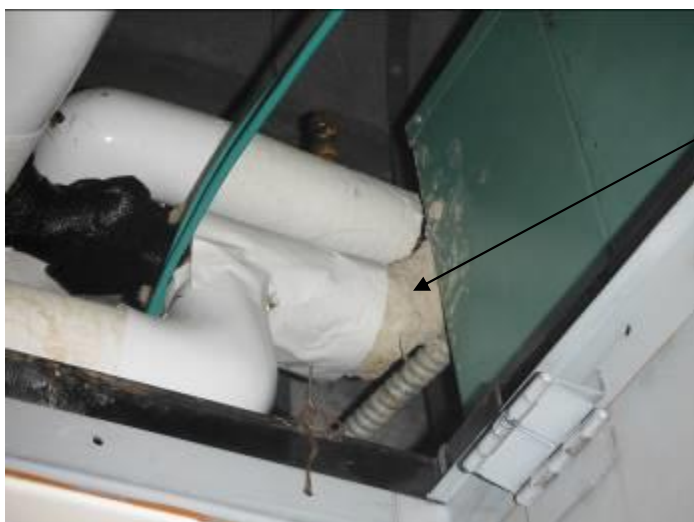
...even tucked in amongst the new materials.

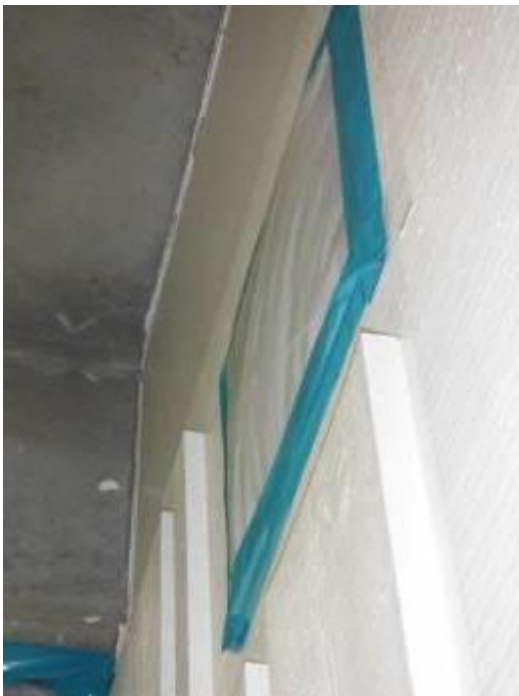
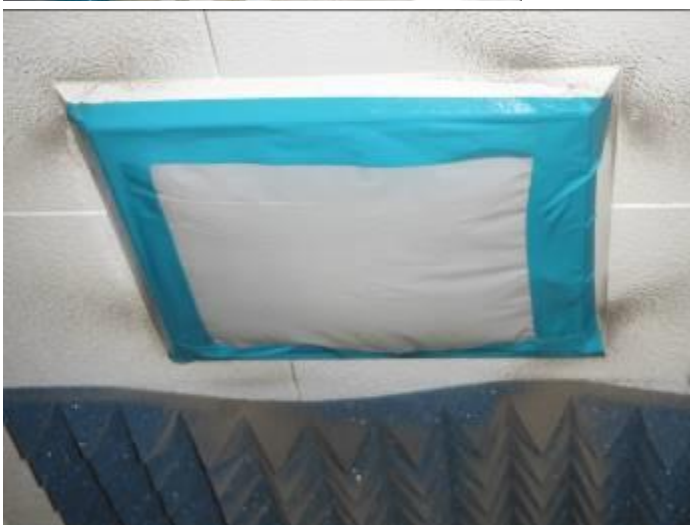
1100 The poly covers over the vents in the Media Services are appear bloated...

...indicating some exiting air flow.

The curtain between the room 108 and the reception area is relaxed, as opposed to billowing out previously, again indicating there may have been air flow out the vents.

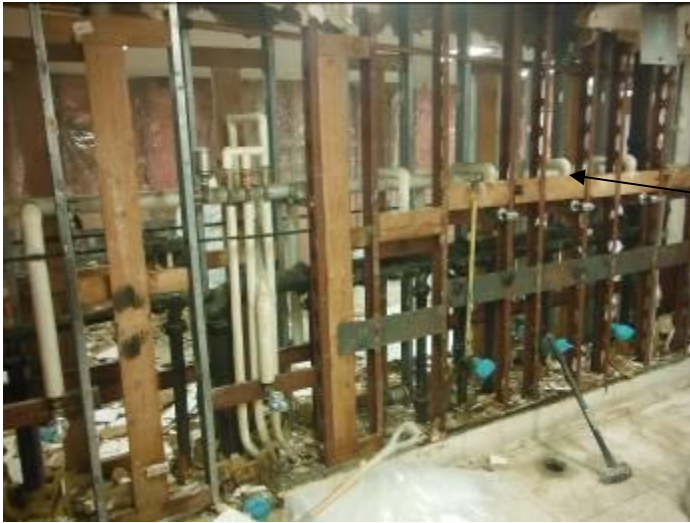
Removal of the restroom drywall and tiles has revealed dozens of hard-packed elbows in both the men's/women's dividing wall...

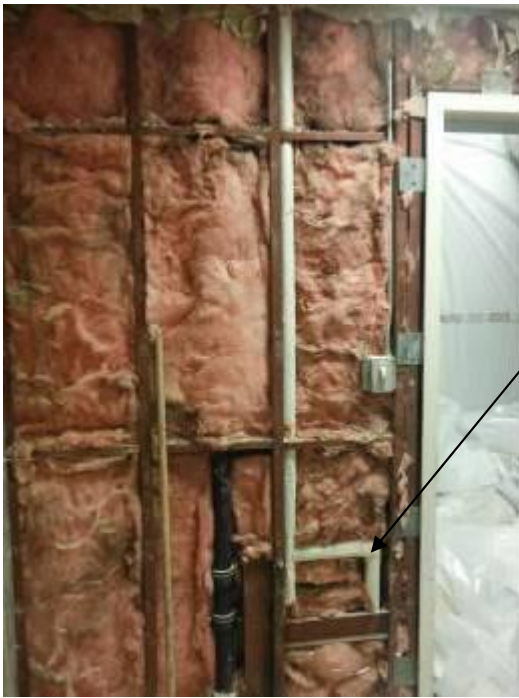
...and the perimeter walls.

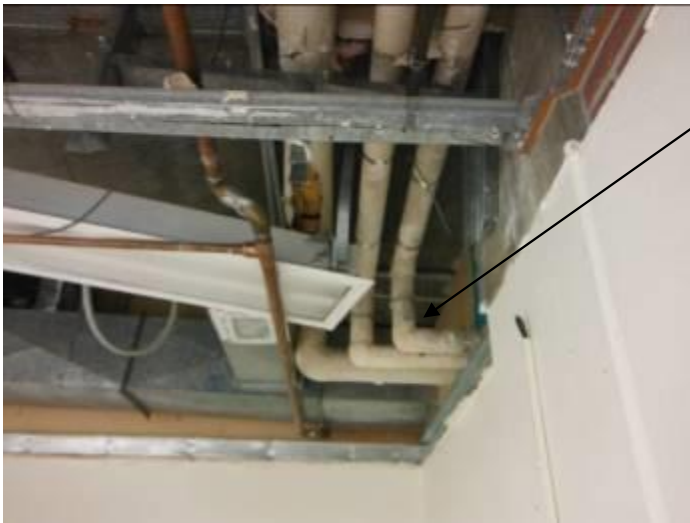
Further demolition of soffits has also revealed more clusters of hard-packed elbows.

RGA estimates there are in excess of 40 x elbows to be abated.

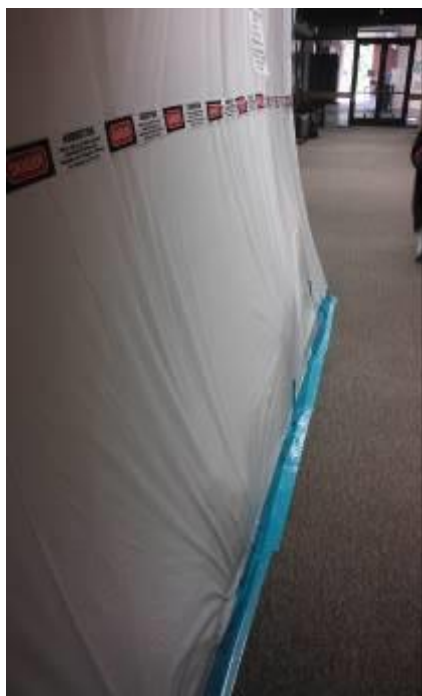
0840 RGA notes stacked bags bulging the critical barrier to the public area. Some have fiberglass insulation, some have ceramic tile.

RGA cautions the crew to avoid straining the poly and causing a breach, especially with the hard, sharp ceramic.

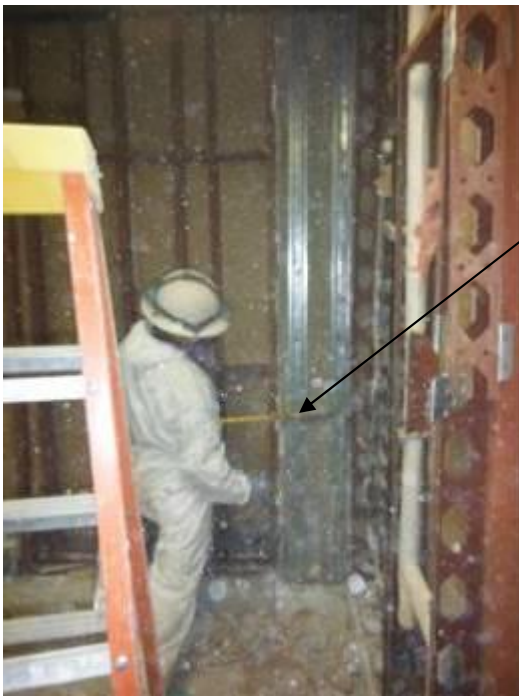
...and pry with crow-bars...

...without adequate dust control, as evidenced by the camera back-flash.

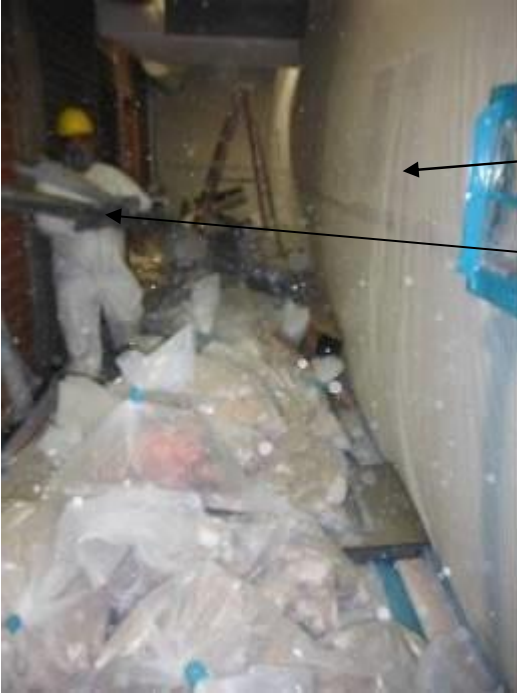
The stack of bagged ceramic debris is growing again, and threatening to tip over against the critical barrier to the library entrance lobby.

RGA also notes metal studs on top of the pile, and points out these could rip the poly open.

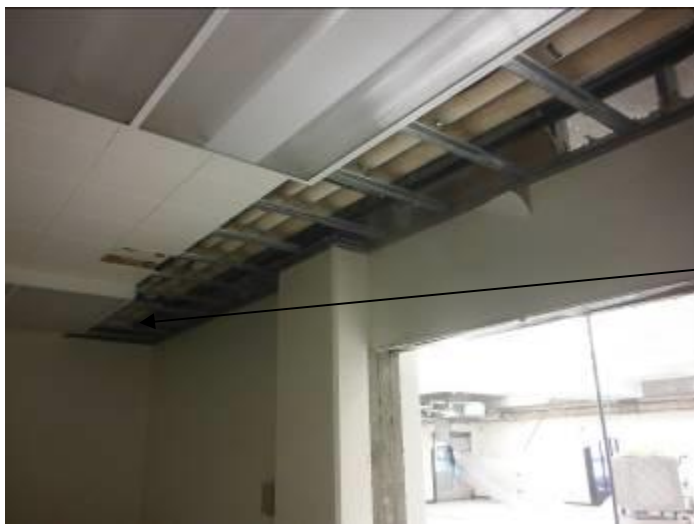
A narrow channel of drop-ceiling tile is removed along the inside edge of the sound studio and adjoining office.

Removal exposes a run of pipes with hard-packed TSI elbows at the end where the pipes change direction. The abatement foreman points out it is fair to assume that there are hard-packed TSI fittings beyond, in the closed plenum.

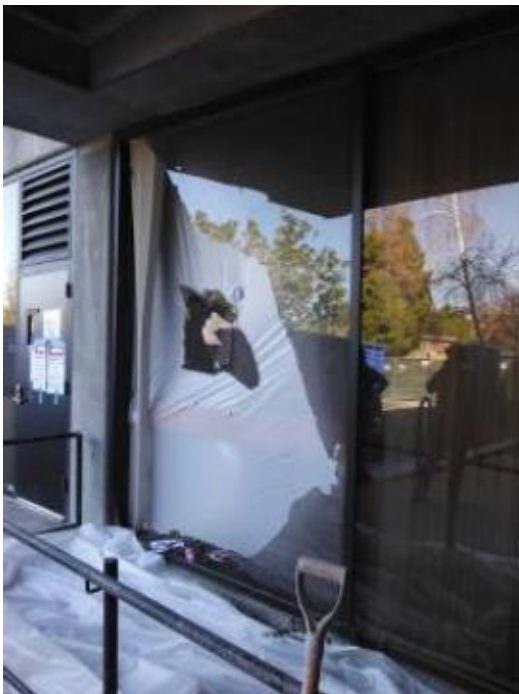
1435 A window pane, just east of the north NAM discharge, shatters. The poly barrier inside holds up, and the crew rapidly pulls down the flap over the now exposed view window. Negative pressure is maintained.

All abatement work stops, and the crew install a second poly critical barrier inside, up against the original.

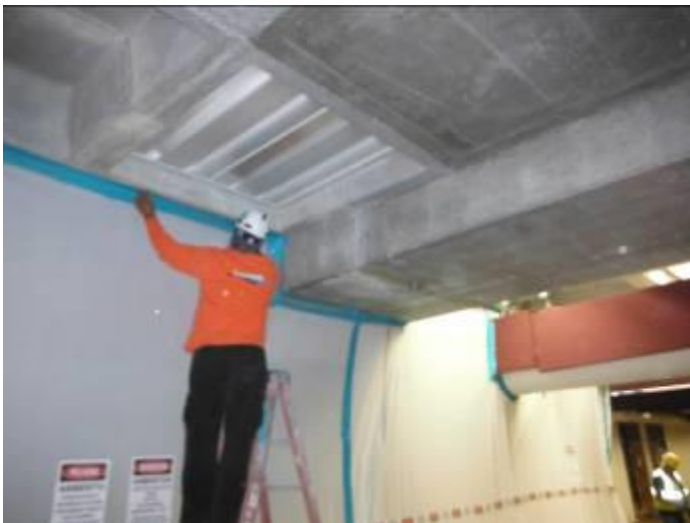
While the critical barrier to the building's interior has remained intact, and negative pressure has been maintained over the weekend, the crew repair and replace tape where some peeling gives the appearance of a breach.

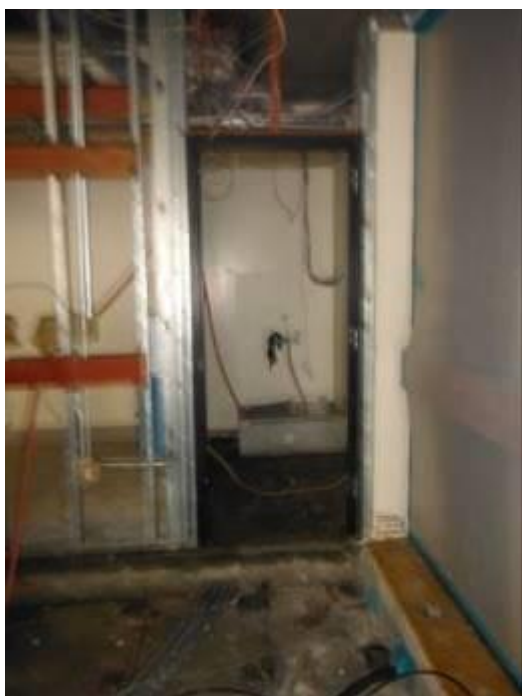
The janitor closet floor, at the southwest corner of the old computer lab, has been abated of all VFT. The pitted floor retains some stains, but RGA is unable to scrape further.
