DAILY PROJECT OVERSIGHT LOG

PROJECT NAME:	Demo/abatement	DATE:	3/2/15
SITE ADDRESS:	DVC, 321 Golf Club Rd, Pleasant Hill	RGA PROJECT NUMBER:	R1147447
CLIENT CONTACT:		HOURS OF WORK:	0700 – 1500
CLIENT PHONE #:			
CONTRACTOR:	CPM Environmental	NUMBER OF WORKERS:	7
RGA REPRESENTATIVE:	N. Arscott	NUMBER OF ACM AIR SAMPLES:	TEM:
			PCM: 4
RGA P.M.:	S. Steiner	NUMBER OF LEAD SAMPLES:	AIR:
			WIPE/BULK:

**PROJECT: R1147447 -
TIME AND ACTIVITY**

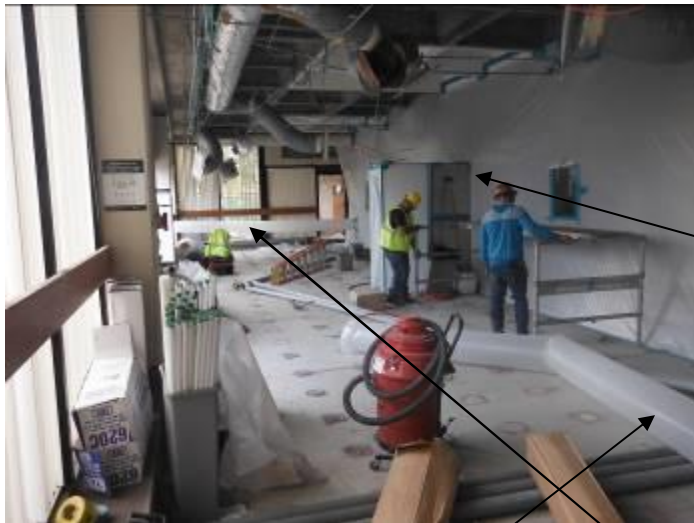
0700 The containment encloses the north-half of the ground floor of the library building.

The shower decon is set into a floor-to-deck poly barrier, set up at the north end, across the old computer lab.

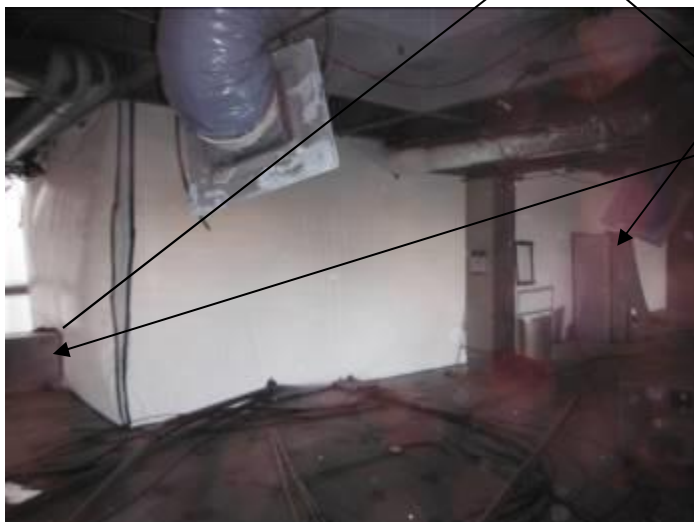
The decon enters a large open space, with 2 x NAMs either let into the barrier, or connected through it with hoses. In both cases the hoses are fed towards the exterior.

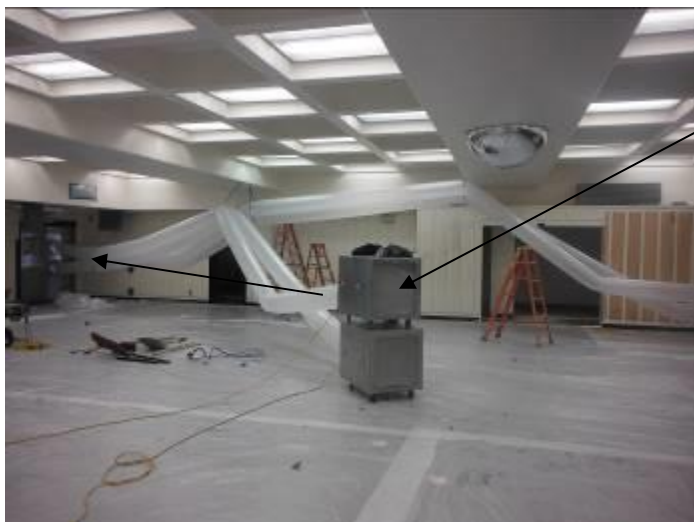
In the open area west of the computer lab, 4 x NAMs, stacked in pairs, are hoses to the exterior via a window manifold.

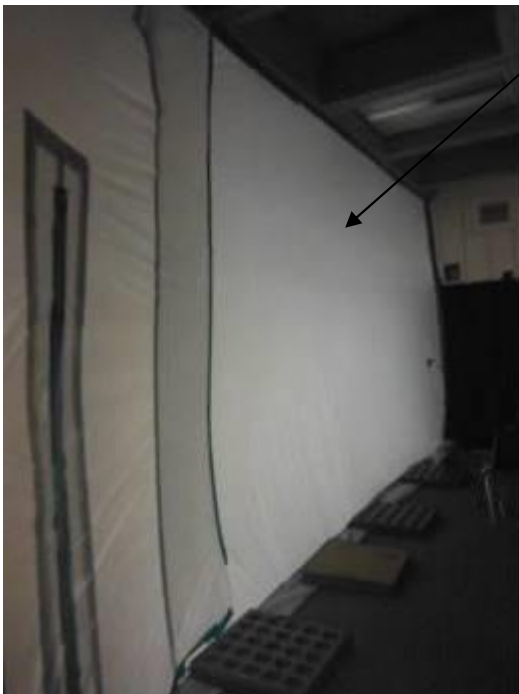
RGA notes very strong negative pressure, and points out that it could strain the tall, floor-to-ceiling poly barriers that separate the containment from the public, and populated, part of the library to the southeast...

...and the Media Services office to the southwest.

The CPM foreman is aware, and states he will monitor the pressure, and reduce it if the tape seams show any signs of yielding. For now, the decon flaps are used to control the pressure down to below -0.050"

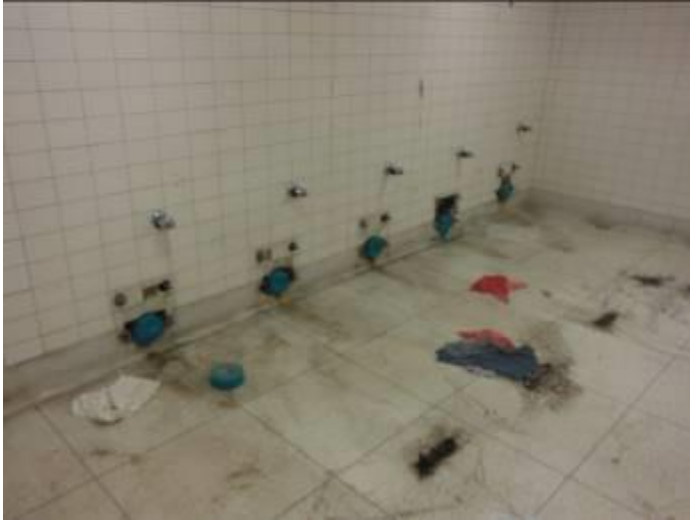
0900 The toilet lines are plugged off with tape, and the smell is subsiding.

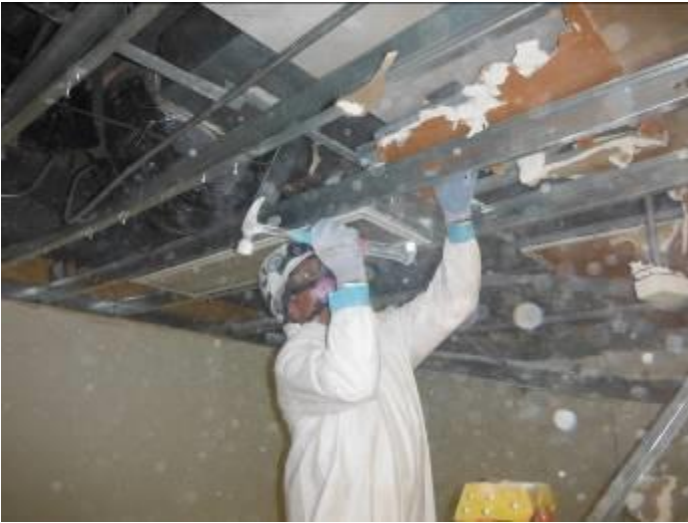
RGA notes the crew all properly wear PPE, including hard-hats and eye protection.

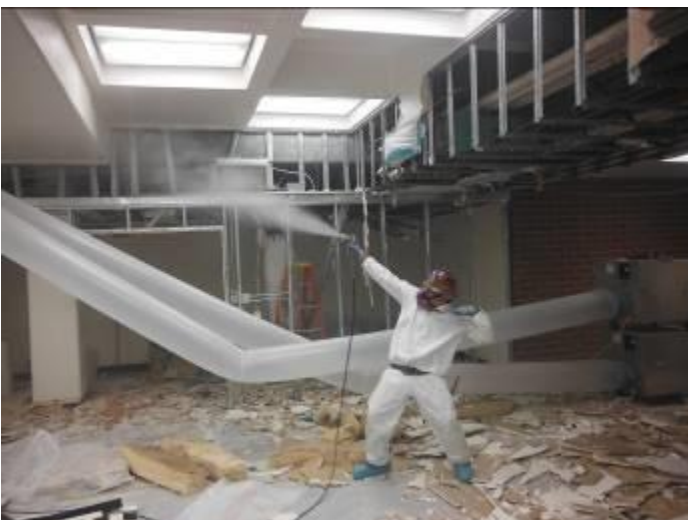
The soffits are mostly stripped of drywall, but RGA notes dust, and exhorts the crew to use the airless sprayer more liberally.

The crew complies.

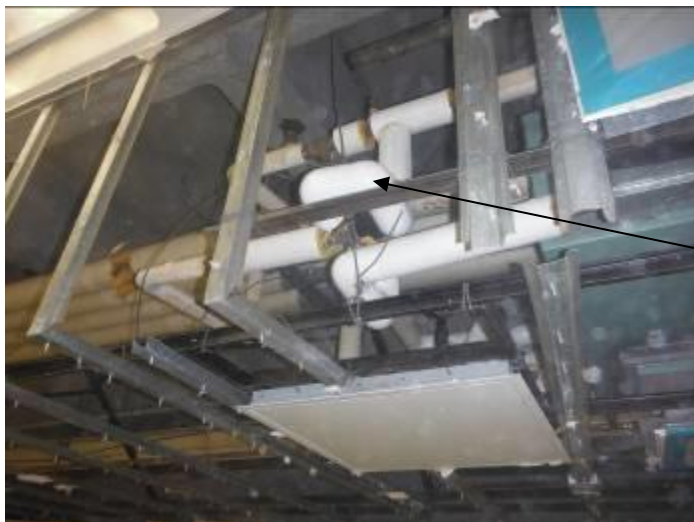
The soffits enclose utility pipes and conduits.

Now that they are open, RGA can see that the TSI appears to have been mostly updated with non-acm material...

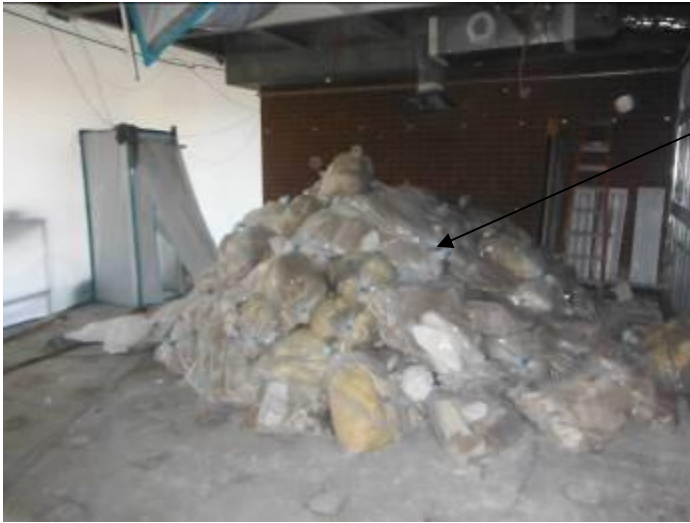
A large pile of bagged drywall awaits load-out, now scheduled for late p.m.

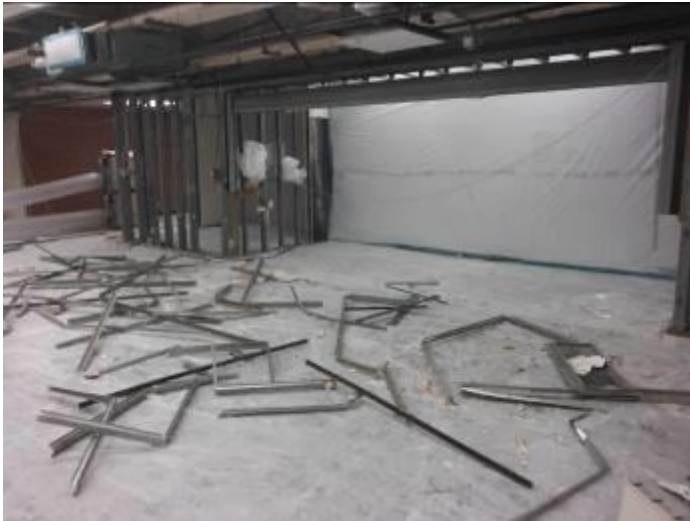
1330 The crew has started saw-zalling the studs. Having found out they will not be salvaged, and will be discarded as non-hazardous waste, the crew does not bother to detail clean them, and "burrito" wraps them with tufts of drywall still attached.

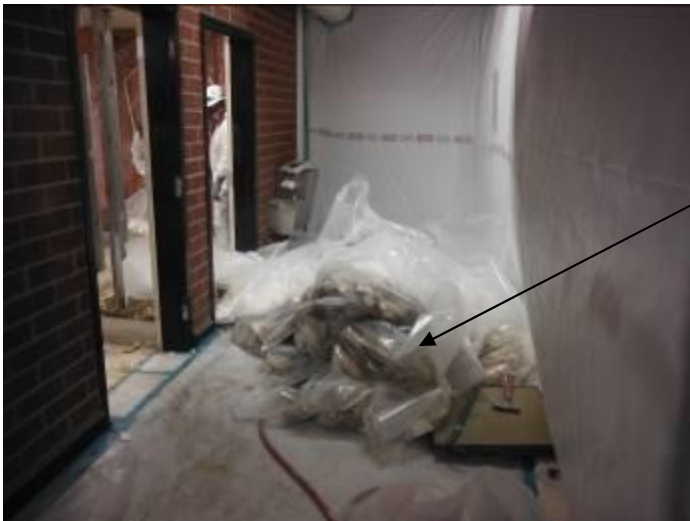
In the restrooms, the wall ceramic tiles are demolished. The debris is bagged, and left outside the restrooms awaiting results of analysis for waste profiling.

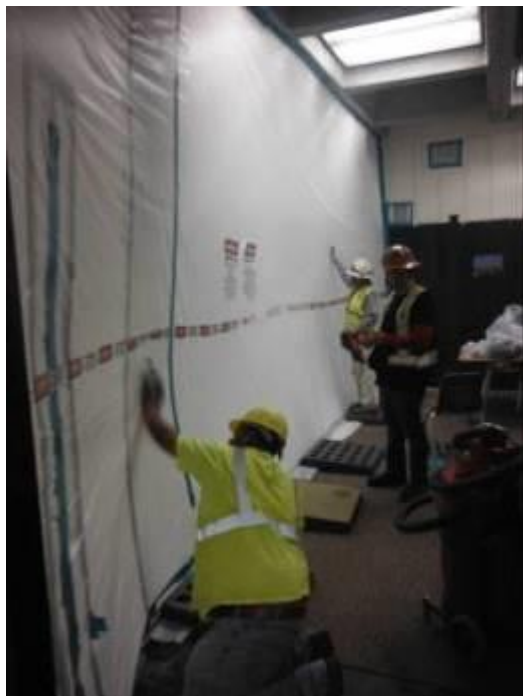
1430 TEM analysis of the PCMs from 3/2 and 3/3 with high fiber counts show all but one having no asbestos fibers. The one sample that exceeded the perimeter clearance criteria is that of 3/3 at the critical barrier to the Media Room.

At RGA's request, CPME sets 3 x workers to wet-wipe the flat surfaces, and HEPA vacuum the floor.

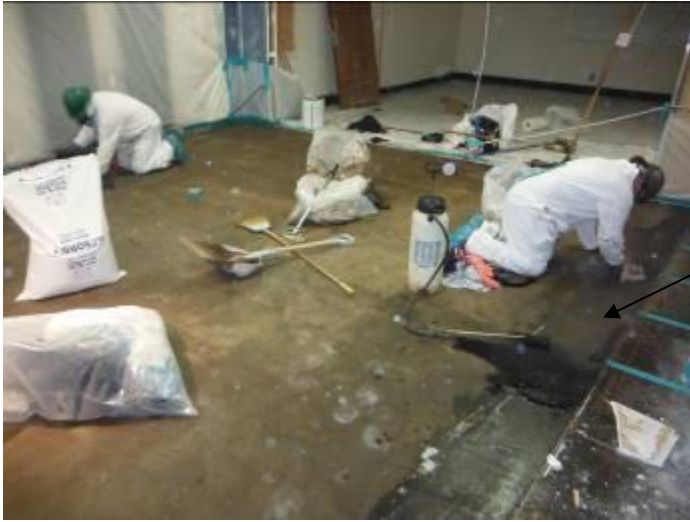
1420 The bulk of the mastic is removed.

2 x crewmen scrape and scrub around the edges where some porous levelling compound retains a dark stain.

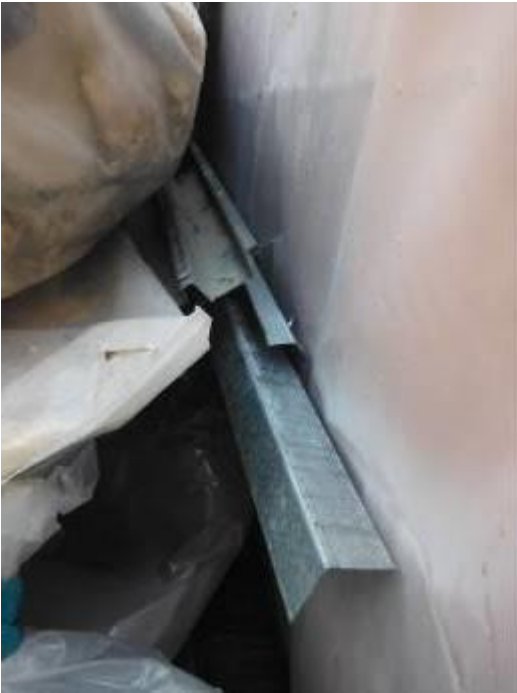
While most of the metal is "burrito" wrapped, some comes out washed, but bare.
RGA ensures no drywall debris is still attached.

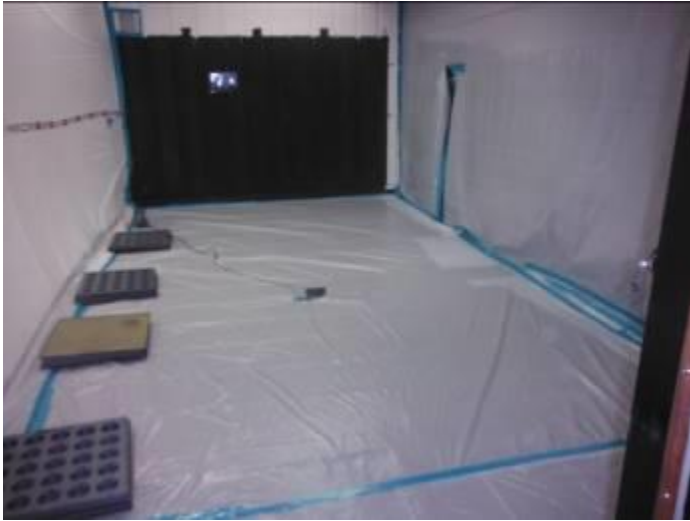
0845 The Media office critical barrier air sample, again, had asbestos fibers.

At RGA's request, CPME lays poly over the carpet, and wipes the area down.

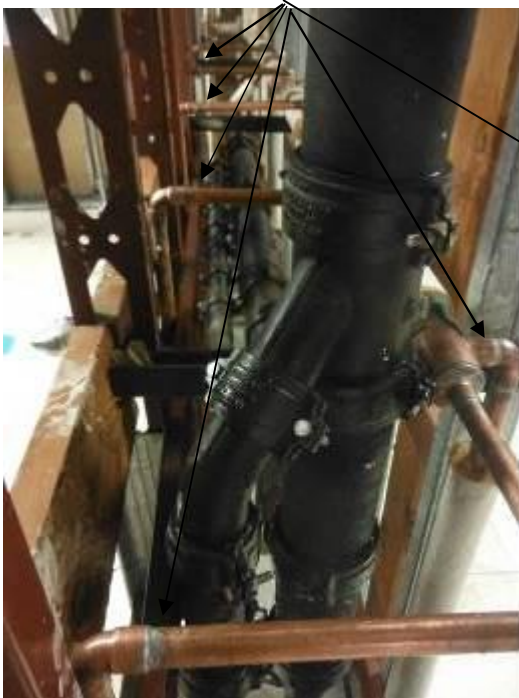
1330 Some of the hard-packed TSI has been removed from the pipe elbows in the restrooms, leaving clean, polished metal...

...inside the dividing wall utilities gap...

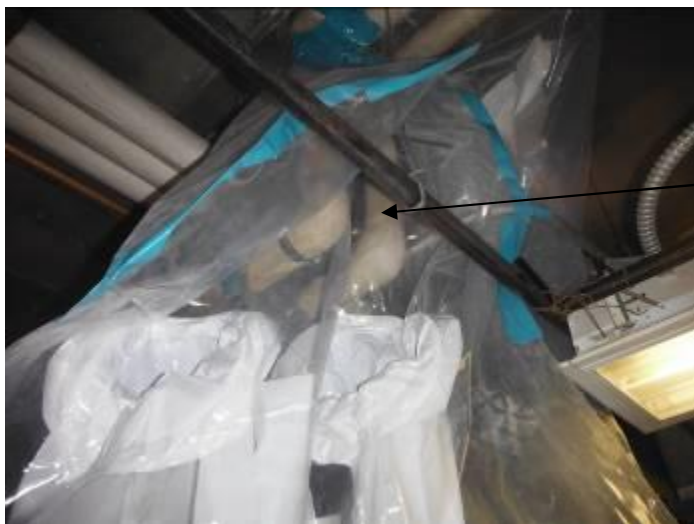
The hard-pack TSI removal is done in glove bags, which, to economize on bags and time, are fitted over clusters of multiple elbows per bag.

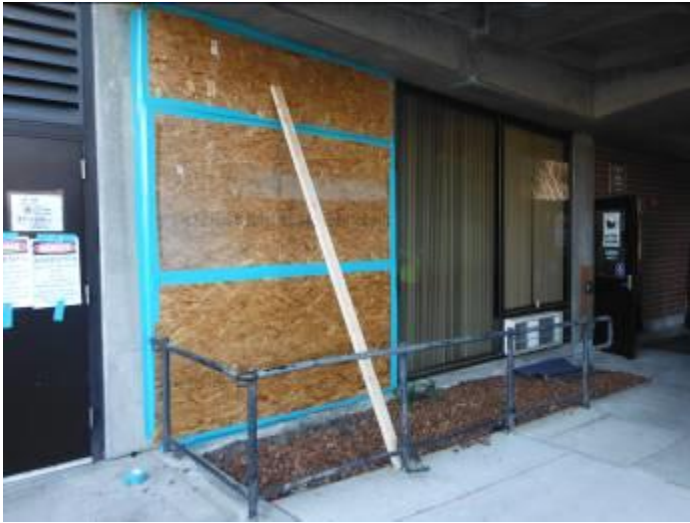
1510 Most of the crew exited to effect repairs at the window opening. The remaining glass left hanging in the frame has been knocked out, and all the glass shoveled up and removed. Sheets of plywood are taped across the opening. After ensuring a good seal, 2 x NAMs are turned off to reduce negative pressure to $-0.022''$, to relax the strain on the floor-to-ceiling critical barriers over the weekend. The rest of the crew doffs PPE, showers and exits.

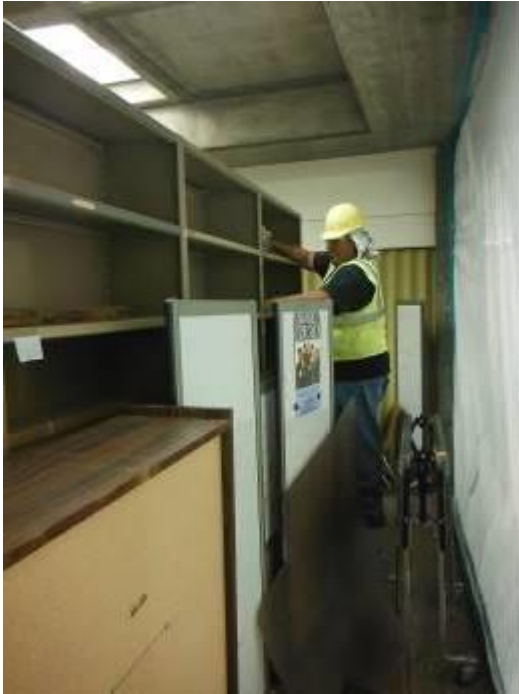
Because of high fiber counts in the library/interior side PCM air samples, with some asbestos fibers identified by TEM, the foreman pulls out 2 x crewmen to wet-wipe and HEPA vacuum the areas adjacent to the critical barriers.

0730 As well as cleaning the floors and poly walls, the crewman opts to wipe the furnishings in the media offices, immediately adjacent to the outer dust barrier.

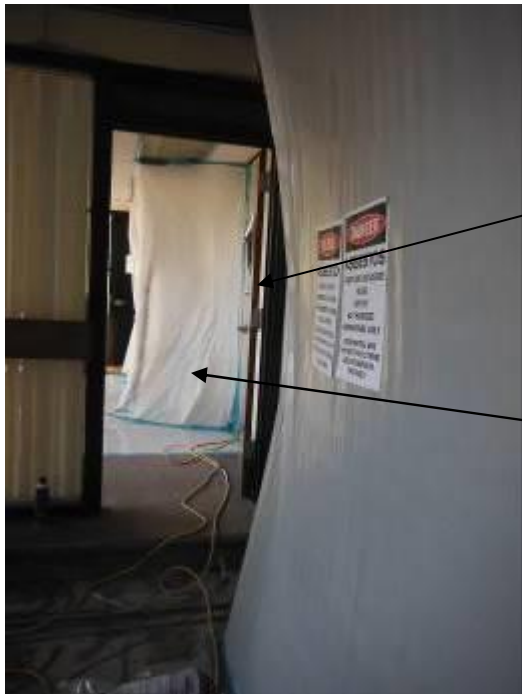
1015 At the east end of the north critical barrier there is a small office, outside containment.

At W.E. Lyons request, the crew has built a small floor-to-ceiling containment against the wall to the contained area.

This allows the crew to cut an opening in the wall, thus merging the small area with the main containment, and opening out a portal for a doorway installation.

RGA notes the negative pressure remains healthy throughout the merge.

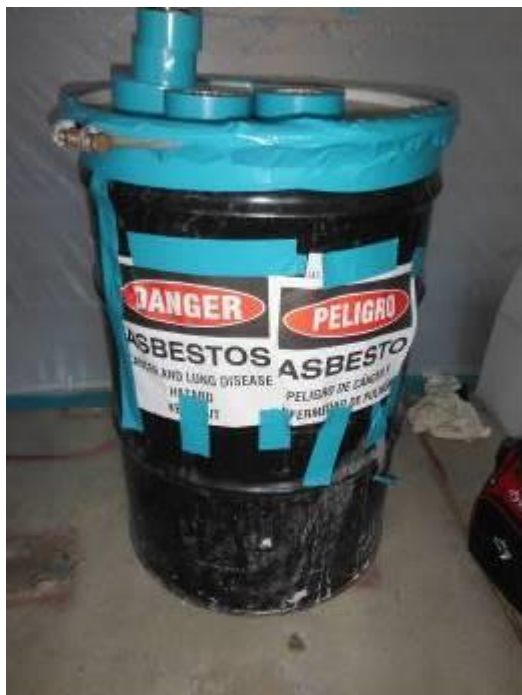
The TSI, contained in the glove bags, has been placed in a drum.

The mastic/solvent slurry, bagged, has also been placed inside.

The drum is sealed, and appropriately labeled.

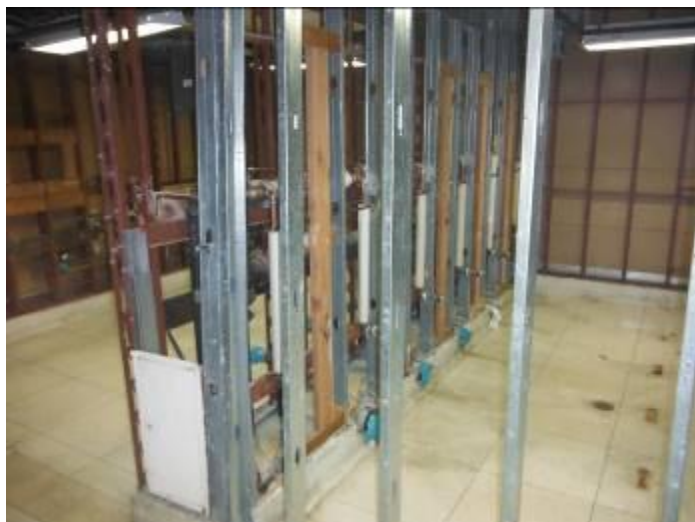
1130 The final visual inspection reveals fully abated, and thoroughly cleaned restrooms.

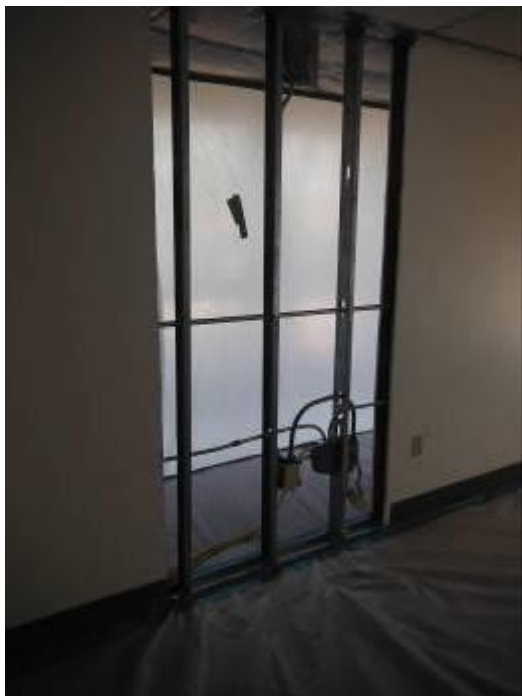
The added containment at the northeast end is wiped clean, and the edges and exposed studding of the new cut-out HEPA vacuumed.

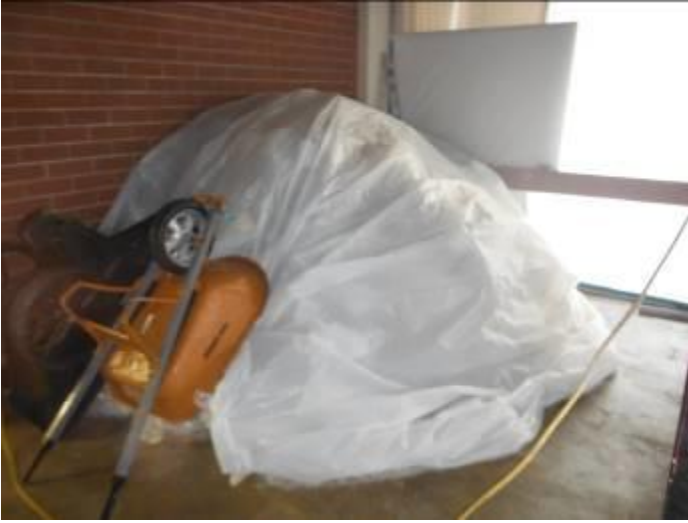
The ceramic tiles, still awaiting waste profiling, are bagged and stacked under poly at the north end.
